Inspection Report

Minerals Regulatory Program

Mine Name: Browns Canyon Rock Quarry	Permit Number: M/043/0017
Operator Name: Castle Valley Stone, LLC.	Inspection Date: October 19, 2011
Inspector(s): L Hepler and W. Western	Time: 9:00 AM
Other Participants: Operators Representative	Mine Status: Active

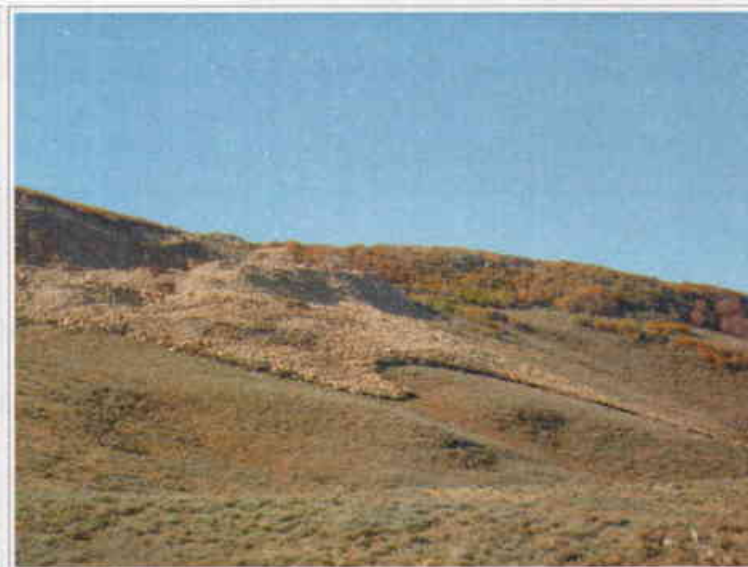
Inspection Summary: At the time of the inspection, Castle Valley Stone had transferred the permit. Footprint at the time of inspection appeared to have expanded further to the west into the ridgeline and the scrub oak. There is a landslide/debris flow that has enlarged the foot print to the north.

Overview of the site – note debris flow

Conclusions and Recommendations: Permit NOI needs to be updated based on current disturbance on the ground and the Operators plan. Bond should be increased to account for the larger footprint. Weeds need to be controlled, as shown in attached photos. OGM to continue annual inspections and monitor the site when in the area.

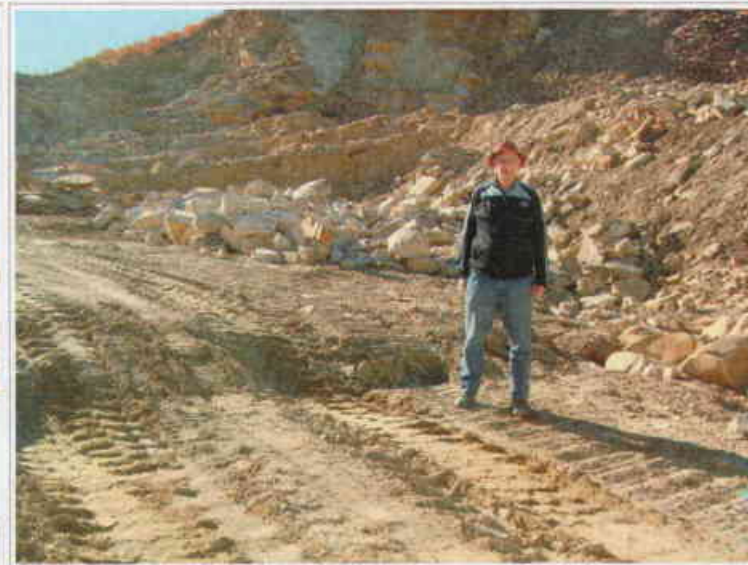
Landslide scarp in the pit

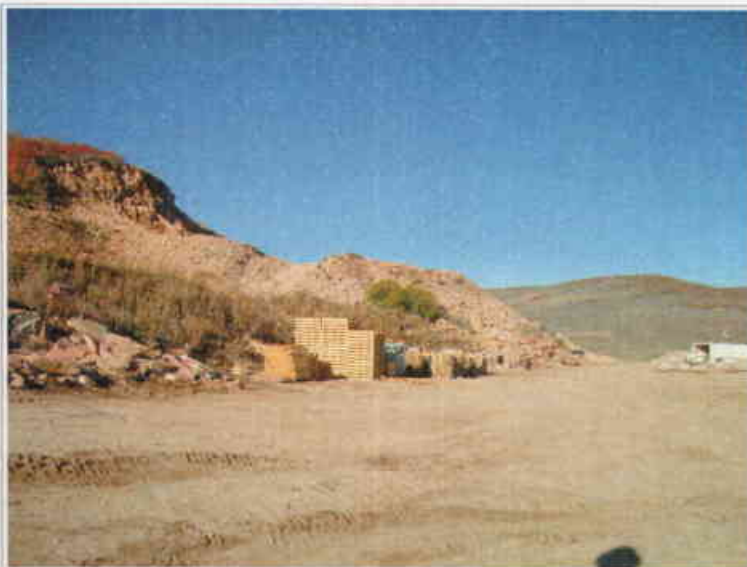
Highwall looking west

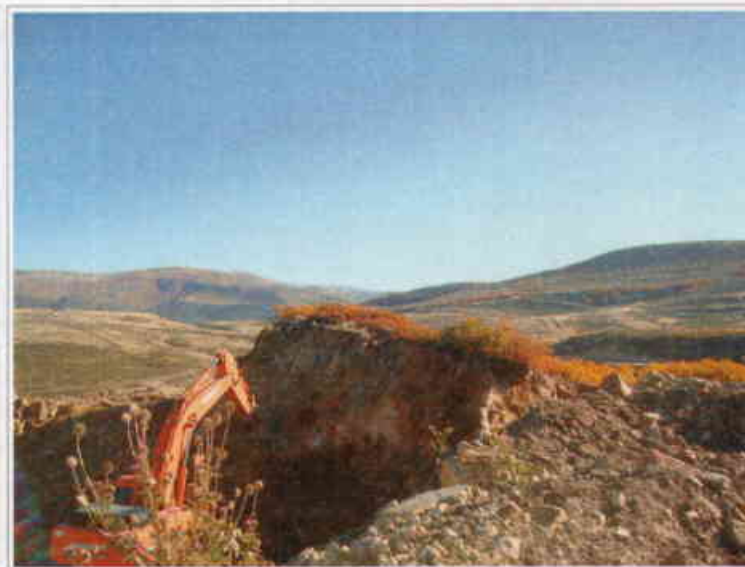
Highwall from the top looking east – note weeds

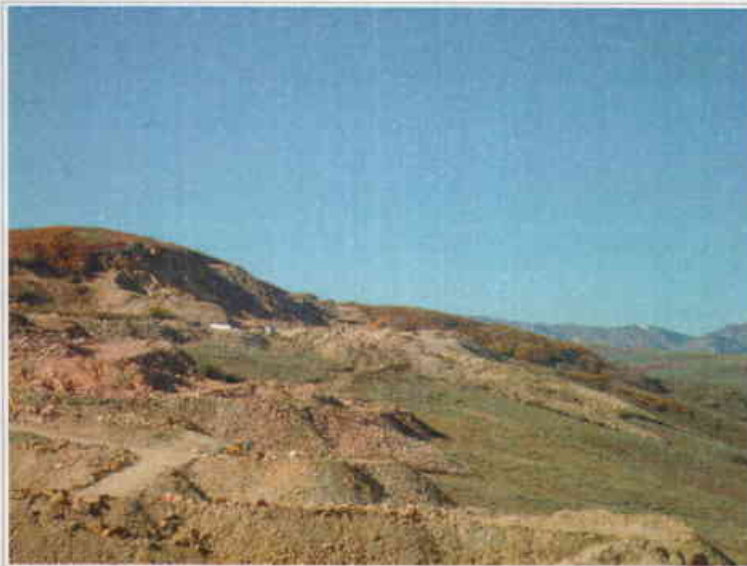
Overview – note west edge of pit
